### BETTER MOUSETRAPS

# NOBLE SAVAGE

A heavy-duty chain cutter helps a Michigan authority clear a severe root blockage from a 30-inch main and restore normal flow

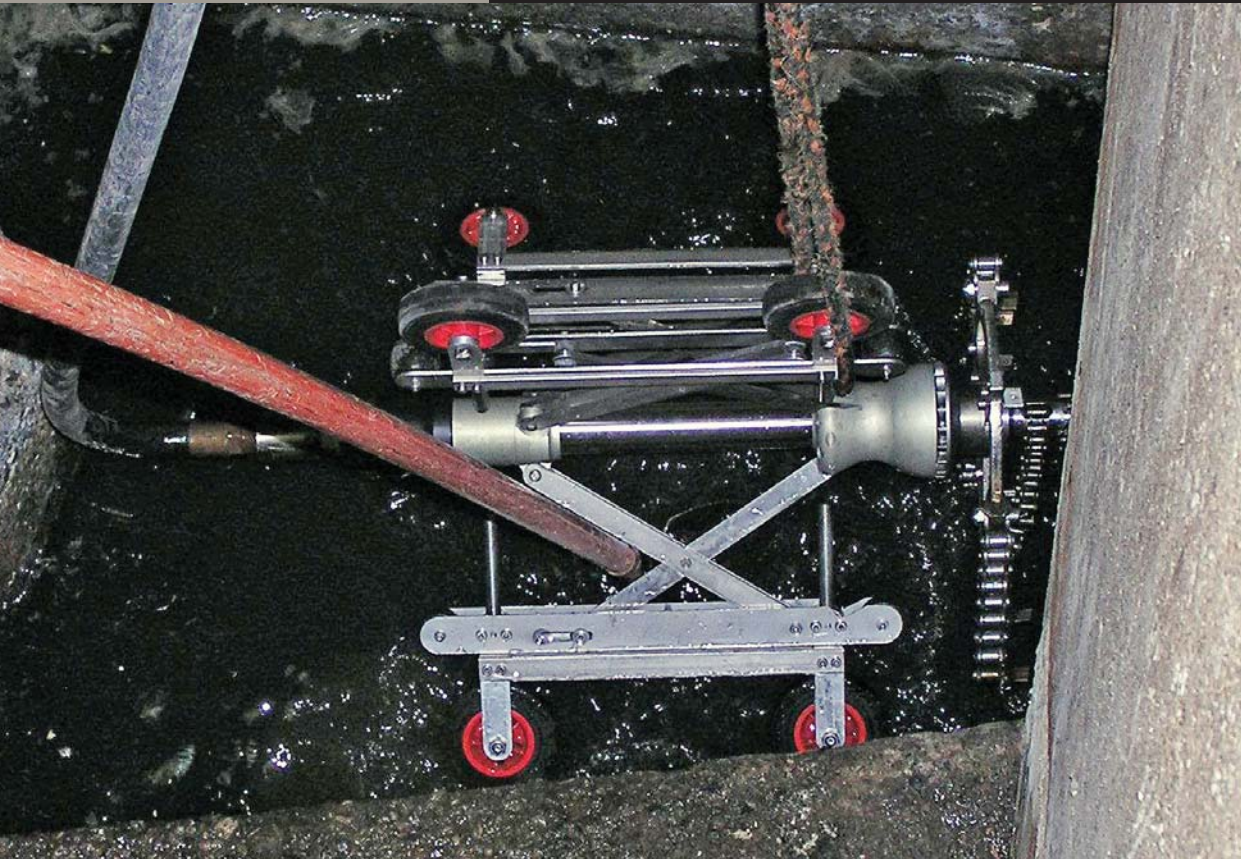
The Turbo III chain cutter helps clear roots from pipes such as this 30-inch sanitary sewer. (Photos courtesy of Ypsilanti Community Utilities Authority)

department. “When we inspected the line, we found four root masses within 130 feet, each 8 to 12 feet long and each blocking 90 percent of the 30-inch concrete pipe.”

Upon inspecting the suspect sewer, Shaffer’s team was alarmed to find the root masses and an ancient bypass handling much of the flow. One root had entered through an abandoned 4-inch lateral. The

other roots had slipped through joints that shifted with the ground. The root masses were confined between the upstream and downstream manholes 130 feet apart.

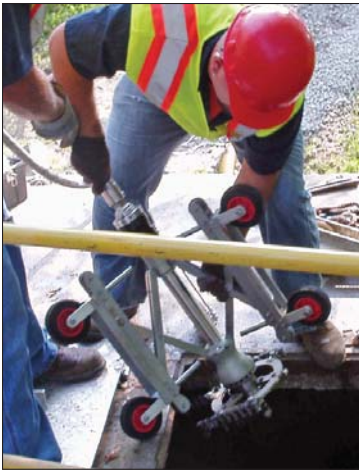
**The Turbo III chain cutter is lowered into a sanitary sewer vault. The tool was powered by a Vactor 2100 Series hydroexcavator supplying water at 70 to 80 gpm.**

Two men at the upstream manhole operated the cutter and Vactor supplying water to the tool through a 1-inch hose. The water shoots onto the cutter's angled fan blades at 70 to 80 gpm, spinning the turbine at 6,000 to 10,000 rpm. The water is channeled separately and has no contact with the cutter's internal bearings. Waterjets at the back of the tool propel it forward.

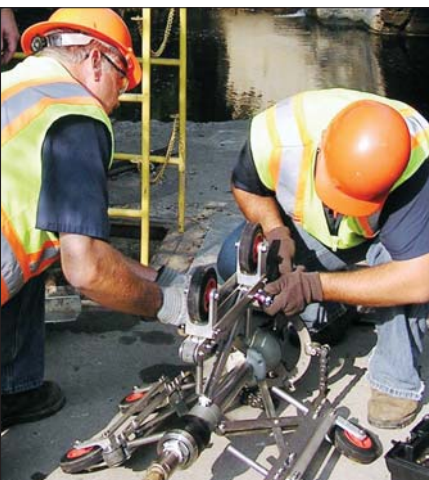
**Line service technicians Tom Everard (left) and Ryan Stetler adjust the expandable frame on the cutter.**

ter. The rails adjust in 1/16-inch increments.

"Adjusting the rails was the biggest thing," says Shaffer. "We made two confined-space entries to test-fit the cutter to the main." Once they locked the rails to the proper distances, Everard and Stetler launched the tool from the top of the vault.
